4. TITLE (and Subtitle) Foundation Report Cold Brook Dam, Hot Springs, South Dakota Fall River Basin		5. TYPE OF REPORT & PERIOD COVERED Final Report
7. AUTHOR(s) U.S. Army Engineer District, Omaha		6. PERFORMING ORG. REPORT NUMBER

FOUNDATION REPORT
COLD BROOK DAM

Hot Springs, South Dakota
January 1954

Revised with Appendix A
Omaha District
December 1983

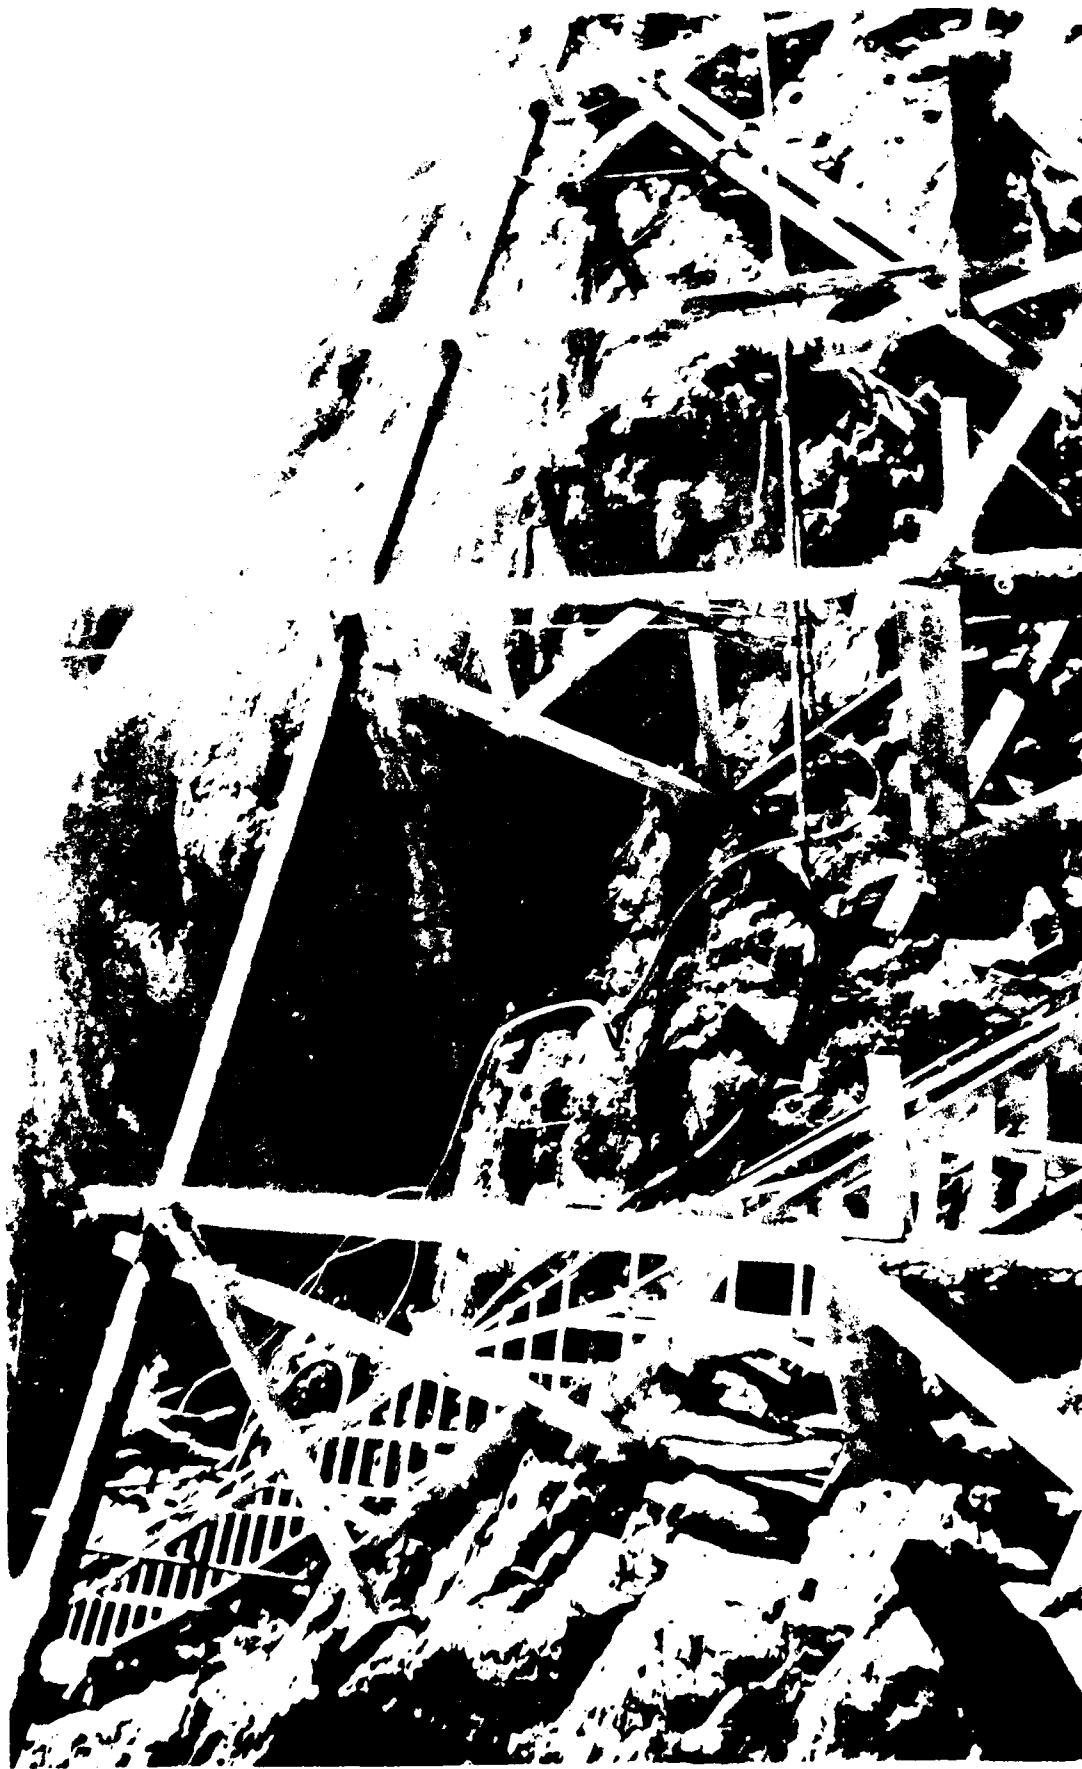
PHOTO NO. 4 VIEW OF STRUCTURE BEHIND ABUTMENT DURING DRILLING
AND GROUTING OPERATIONS.

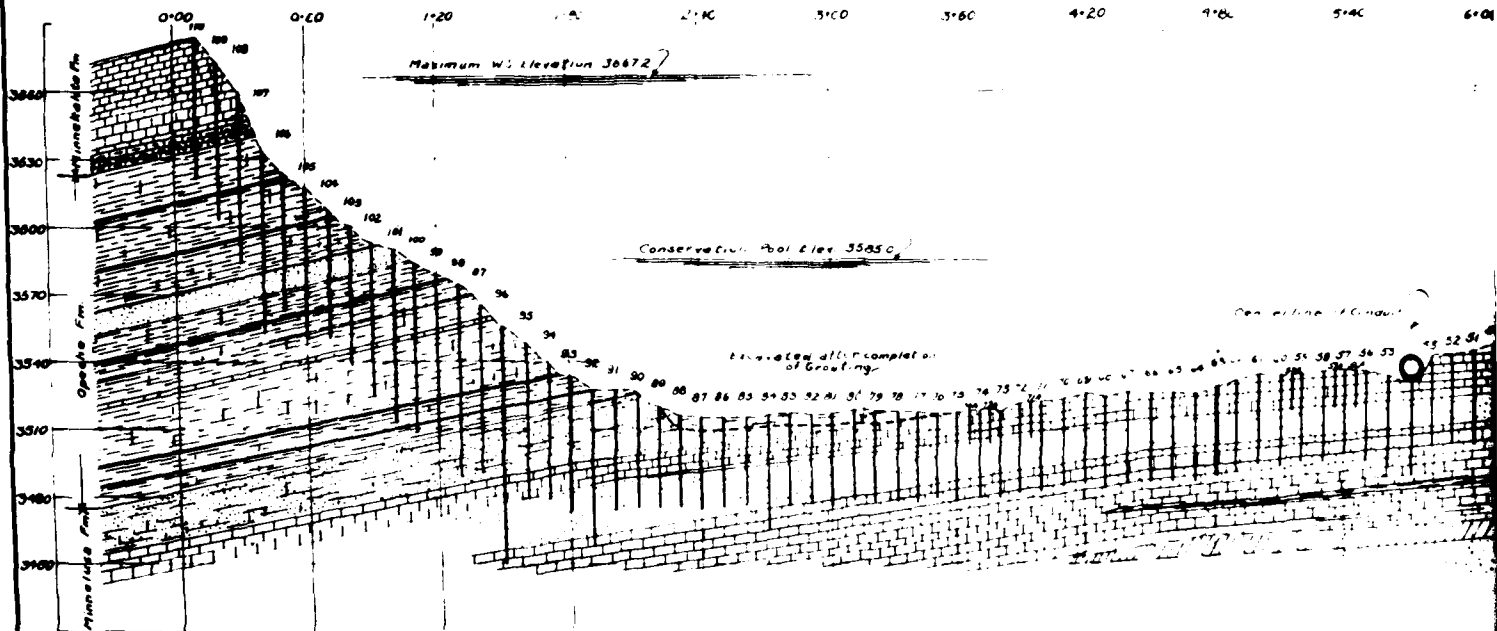
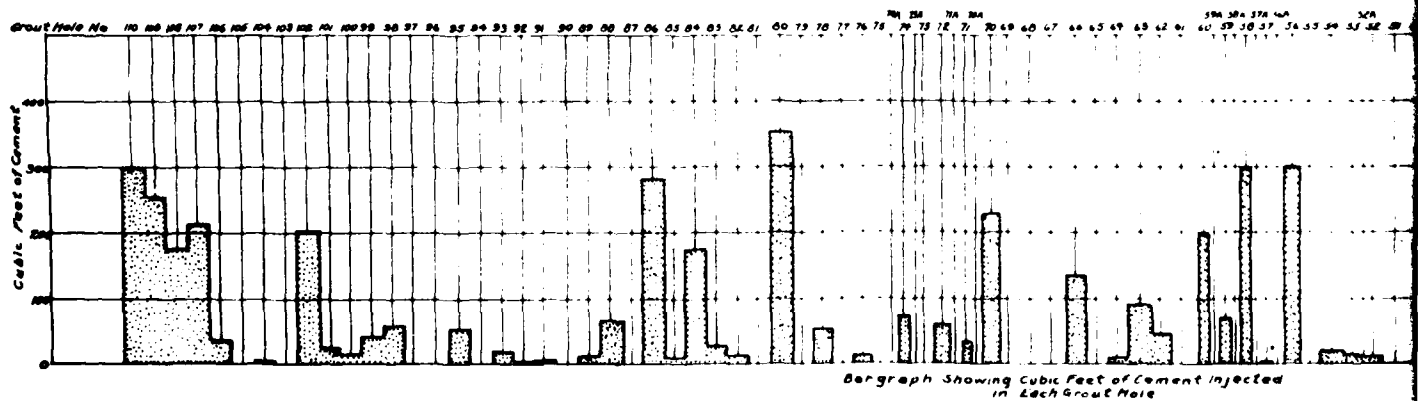
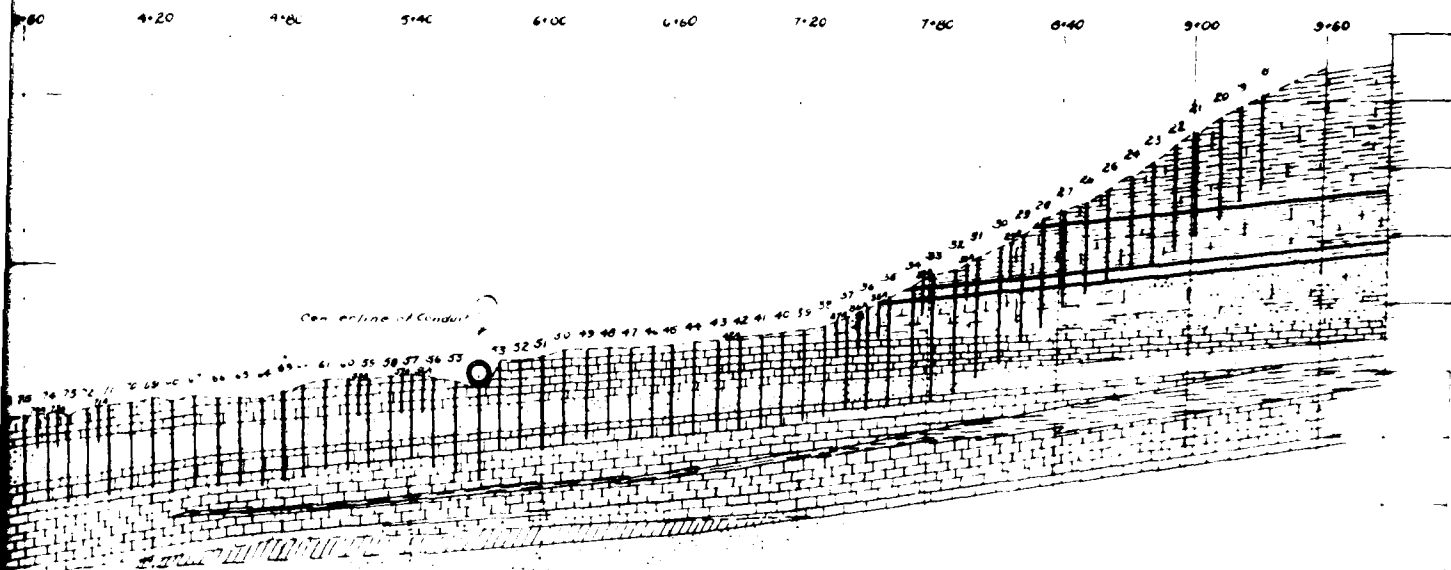
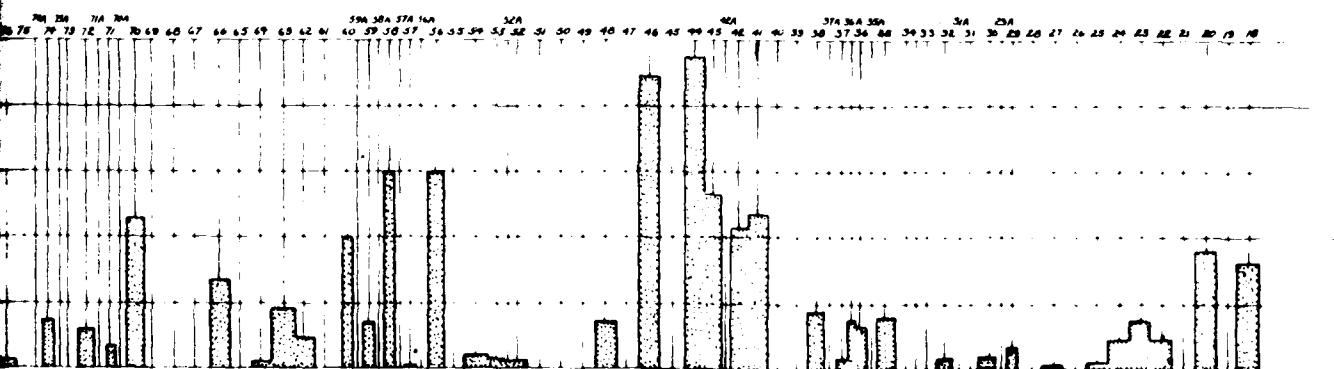
Geological Section Along Center Line of Cutoff Trench
Showing Location and Depth of Grout Holes and Final Excavation Line
Section A-A

An examination of the outcropping Minnelusa formation located one mile upstream from the dam disclosed that a well defined bedding plane exists at the contact between the sandstone and lower limestone, the same zone which required the large volume of grout in the above mentioned holes. In places, this bedding plane at the contact has been leached out and many small pockets and cavities are present. It is believed that the same conditions prevailed beneath the dam and these cavities were the primary reason why such a large volume of grout was required in the 30 to 40 foot zone.

An analysis of the grouting operations at Cold Brook Dam discloses that 4666.5 feet of holes were drilled in the foundation and 6786.7 bags of cement were injected which is an average of 1.45 bags of cement per foot of hole drilled. This relatively high quantity of grout does not tell the full story, for as described elsewhere in this report, a large percentage of the grout was consumed in localized zones of the foundation. The large consumption of grout in local zones, many of them close to the surface, clearly demonstrates that the entire grouting program was justified.

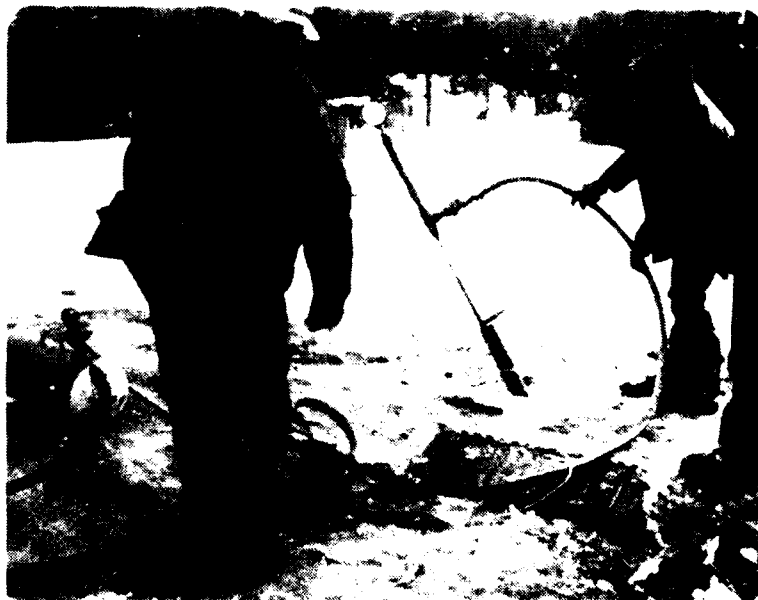
PHOTO NO. A-7: Water pressure test showing header, pressure gauge, packer inflation line and water meter.
